Superior Coal Mines,
Concrete Foundation
Sections 28, 29, T21N, R102W
Horse Thief Canyon
Old Superior Mines and Townsite
about 1/4 mile north of South Superior -
Sweetwater County & *South Superior vicinity*
Wyoming

HAER No. WY-51-Q

HISTORIC AMERICAN ENGINEERING RECORD

Superior Coal Mines, Concrete Foundation
HAER No. WY-51-Q

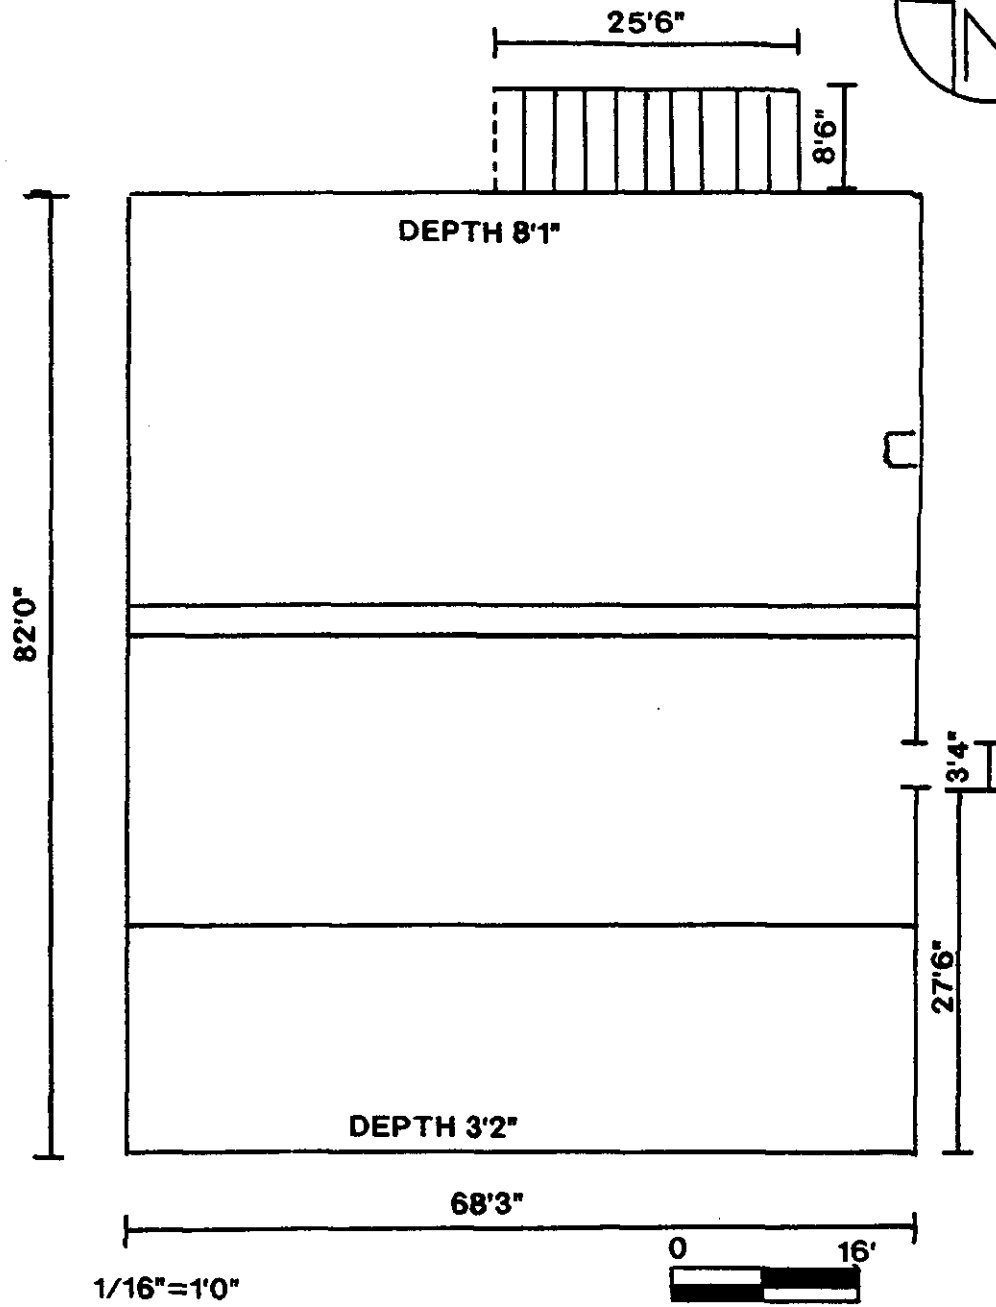
The foundation forms the remainder of a demolished building. It is rectangular in shape with the long axis running from north to south. The overall dimensions are 82 feet 0 inches north to south by 68 feet 3 inches east to west. The south end of the building has a raised concrete platform 19 feet 6 inches wide north to south running the width of the building. The platform is 4 feet 8 inches above the remaining sections of the floor. Along portions of the south wall in the southeast and southwest ends of the foundation pale green ceramic tiles are present. The tiles are shower or bathroom tiles. Additional loose tiles are strewn across the concrete platform floor. North of the concrete platform the floor of the structure drops to approximately 8 feet below present ground surface. The concrete floor is covered with loose brick from the walls of the structure. An opening is present in the east wall of the foundation. This opening is a doorway. It is located 27 feet 6 inches north of the southeast corner and is 3 feet 4 inches wide and extends 6 feet 3 inches above the level of the floor. No door is present and the doorway is blocked by piles of earth. A short stub of a concrete dividing wall is present 22 feet 7 inches south of the north wall. Most of this dividing wall was removed and little remains. The final feature on this foundation is a concrete staircase located along the exterior of the north wall. The staircase ascends from east to west, however, the uppermost end has collapsed so that the total length is no longer present.
